A Case Study of the Rehabilitation of Sulphide Tailings At the Coldstream Mine, Tailings Management Area No. 2

Key Words: mine reclamation, acid mine drainage, water covers, environmental rehabilitation

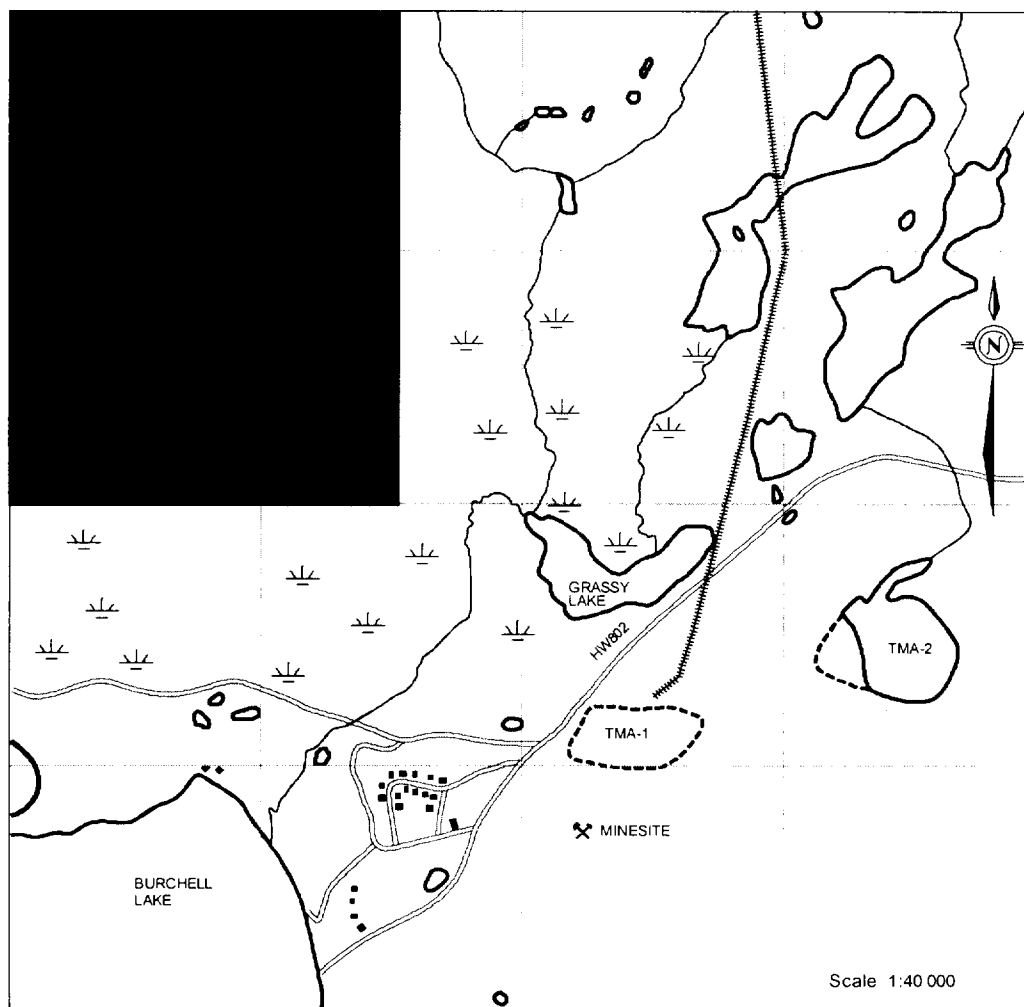
FIGURE 1

The North Coldstream Copper Mine Property is located in northwestern Ontario at the terminus of a tertiary road, Highway 802, approximately 11 km south of the hamlet of Kashabowie. Figure 1 shows the site layout and a key plan to the location. Copper deposits were first discovered in the area in 1870 and about 6000 tonnes of ore were mined during the First World War. Mining commenced on the site in the early 1950's and the mine operated on and off until 1967 when operations ceased and the mine became dormant. A total of approximately 2.7 million tonnes of sulphide tailings were produced during the life of the mine and discharged to two licensed tailings impoundment areas designated TMA-1 and TMA-2. From the early 1950's until about 1962 tailings were discharged to a natural valley to form TMA-1. The impoundment was controlled by a containment structure constructed of stacked tailings and waste rock. Once this area was filled the company received approval from the then Department of Lands and Forests to utilize a small lake, locally known as Halet Lake, as its tailings disposal area designated TMA-2. Approximately one half million tonnes of sulphide tailings were discharged to this basin to the end of the mine's life, creating a tailings beach of about 3.0 ha in area and covering the bottom of the pond with tailings.

COLDSTREAM COPPER TAILINGS PROJECT SITE LOCATION PLAN
